HYUNDAI NEW THINKING. NEW POSSIBILITIES. Technical Service Bulletin	GROUP CAMPAIGN	NUMBER 16-01-020
	DATE APRIL 2016	MODEL(S) SONATA HYBRID (LF HEV) SONATA PLUG-IN HYBRID (LF PHEV)
SUBJECT: ENGINE ELECTRIC WATER PUMP WIRING (SERVICE CAMPAIGN TDD)

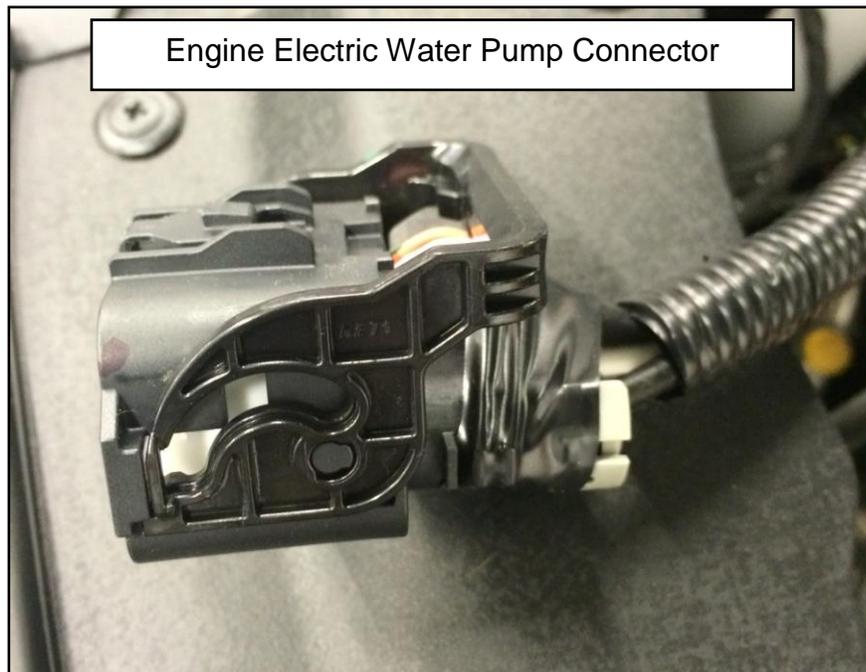
Description: Some 2016 Sonata Hybrid and Plug-In Hybrid vehicles may experience a power reduction accompanied by illumination of multiple warning lights in the instrument cluster. This condition may be due to an intermittent electrical short between the vehicle's 12 volt power and the Control Area Network (CAN) "High" signal in a circuit board in the Engine Electric Water Pump (EEWP). This bulletin describes the service procedure to modify the EEWP wiring harness to eliminate the potential for a short of the CAN signal.

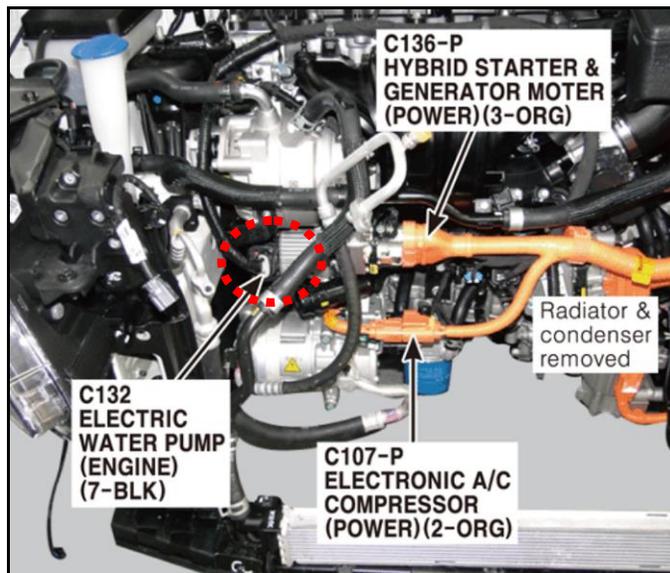
The Engine Electric Water Pump connector is located under the HSG (Hybrid Starter Generator).

Image to the right illustrates the location of the Engine Electric Water Pump Connector.
